SPOKANE JUNK YARD FENCE REPAIR  
TRIP REPORT

DATE: 12 November 1992  
TO: William L. Carberry, TATL, E & E, Seattle, WA  
FROM: Charles J Granda, E & E, Seattle, WA  
SUBJ: Spokane Junkyard Fence Repair  
REF: TDD T10-9211-015

To repair a damaged fence surrounding the Spokane Junk Yard facility, which in turn would restrict access of unauthorized personnel into the contaminated area.

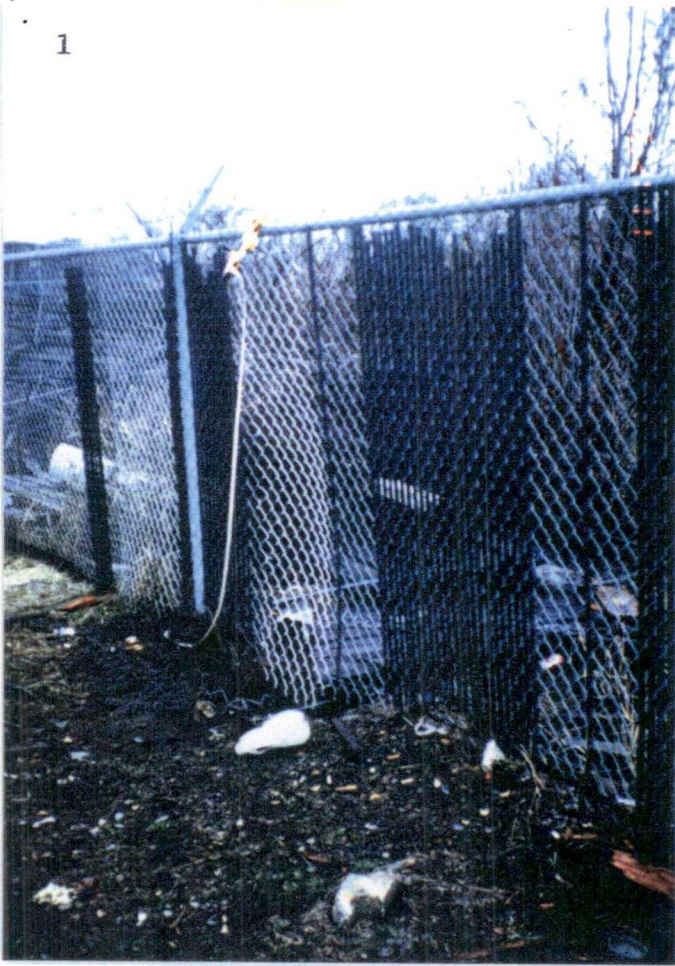
1

Photo No.	Date	Taken By	Description
1)	11/12/92	C.Granda	Repair #1, hole cut through the fence 3 feet wide, and the barbed wire at top was also cut. Repaired area shown in picture. This spot was heavily traveled, and is 166 feet from the SW corner.

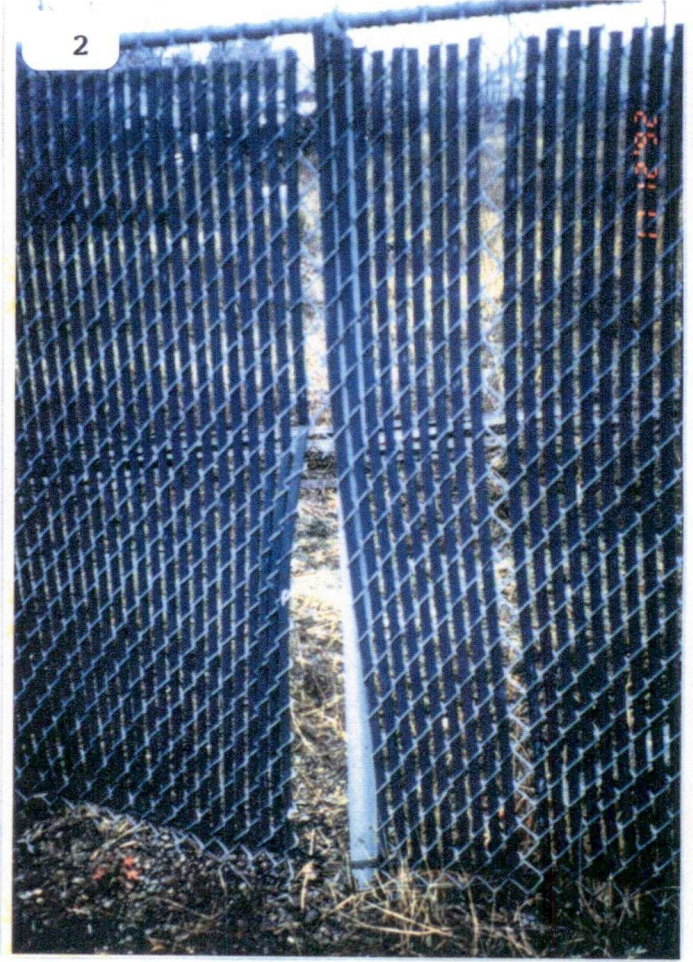
2

2)	"	"	Repair #2, 3 feet tall slice in fence, and 289 feet from SW corner. Easy access by lifting fence. Picture before repair.
3)	"	"	Repair #2, after picture #2 and repair, and fence lashed together with 1/4 inch wire found on site.

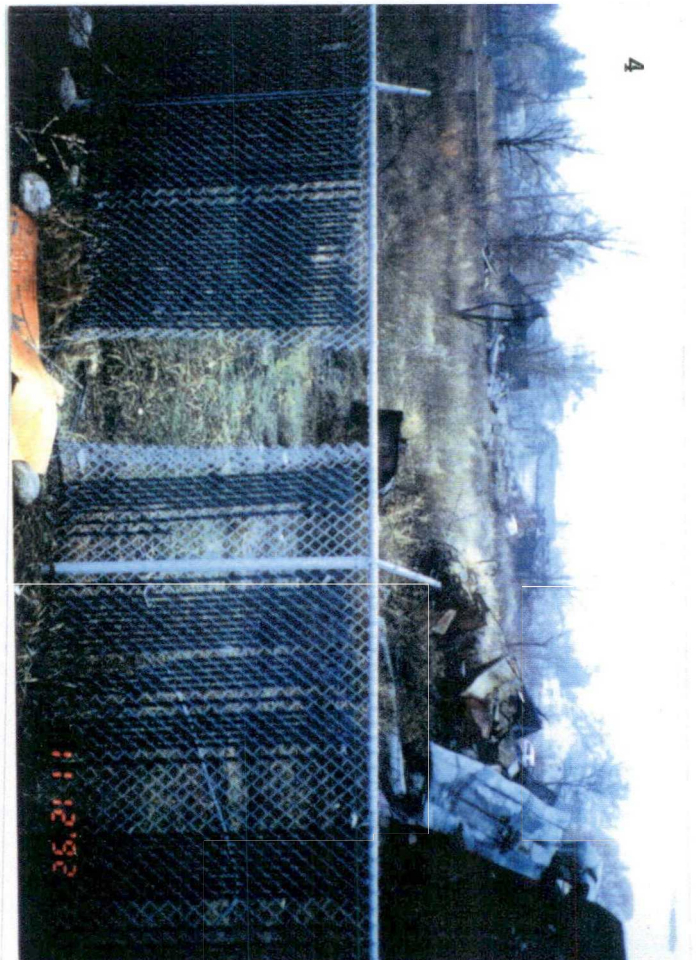
4

4)	"	"	Repair #3, 2 foot gap in fence, lightly traveled area 360 feet from the SW corner. Barbed wire was also cut.
5)	"	"	Repair #3, replaced barbed wire above the fence and installed new fence in the cut out.

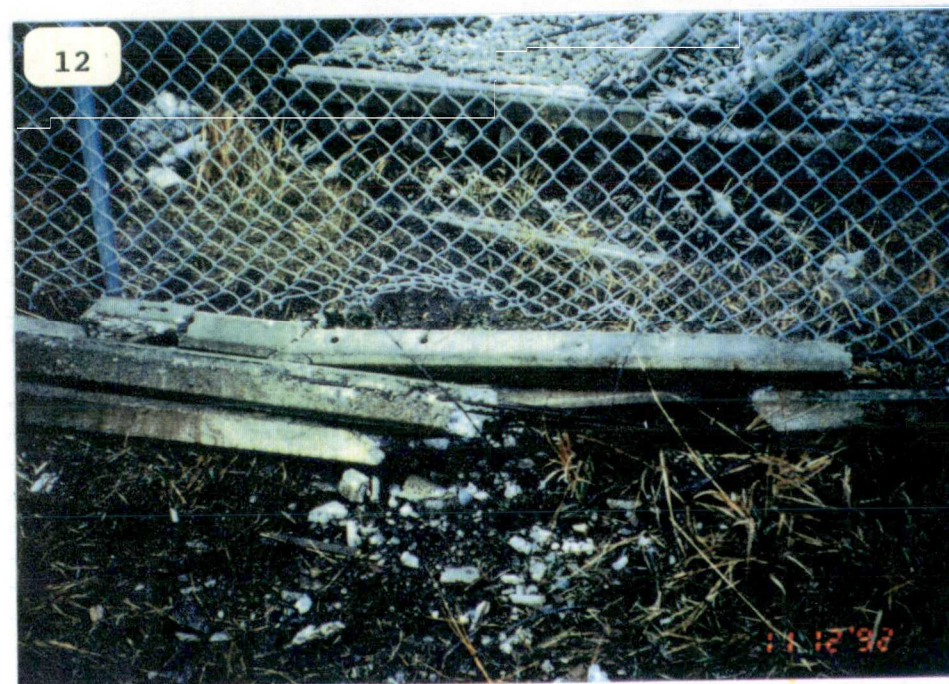
10)	"	"	Repair #6, 2 foot gap under fence 680 feet from SW corner, this area was heavily traveled.
11)	"	"	Repair #6, side view of gap.
12)	"	"	Repair #6, close up of concrete posts lashed into place with barbed wire.

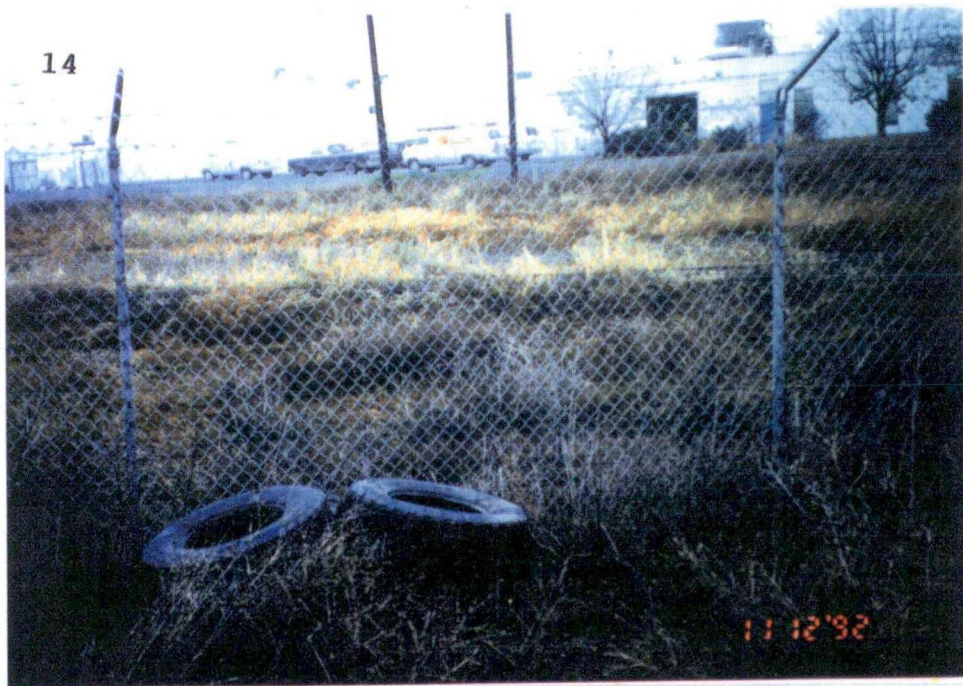
13)	"	"	Repair #6, distance view of gap.
14)	"	"	Repair #7, 1 foot gap under fence, and lashed tires under fence with barbed wire to prevent access.

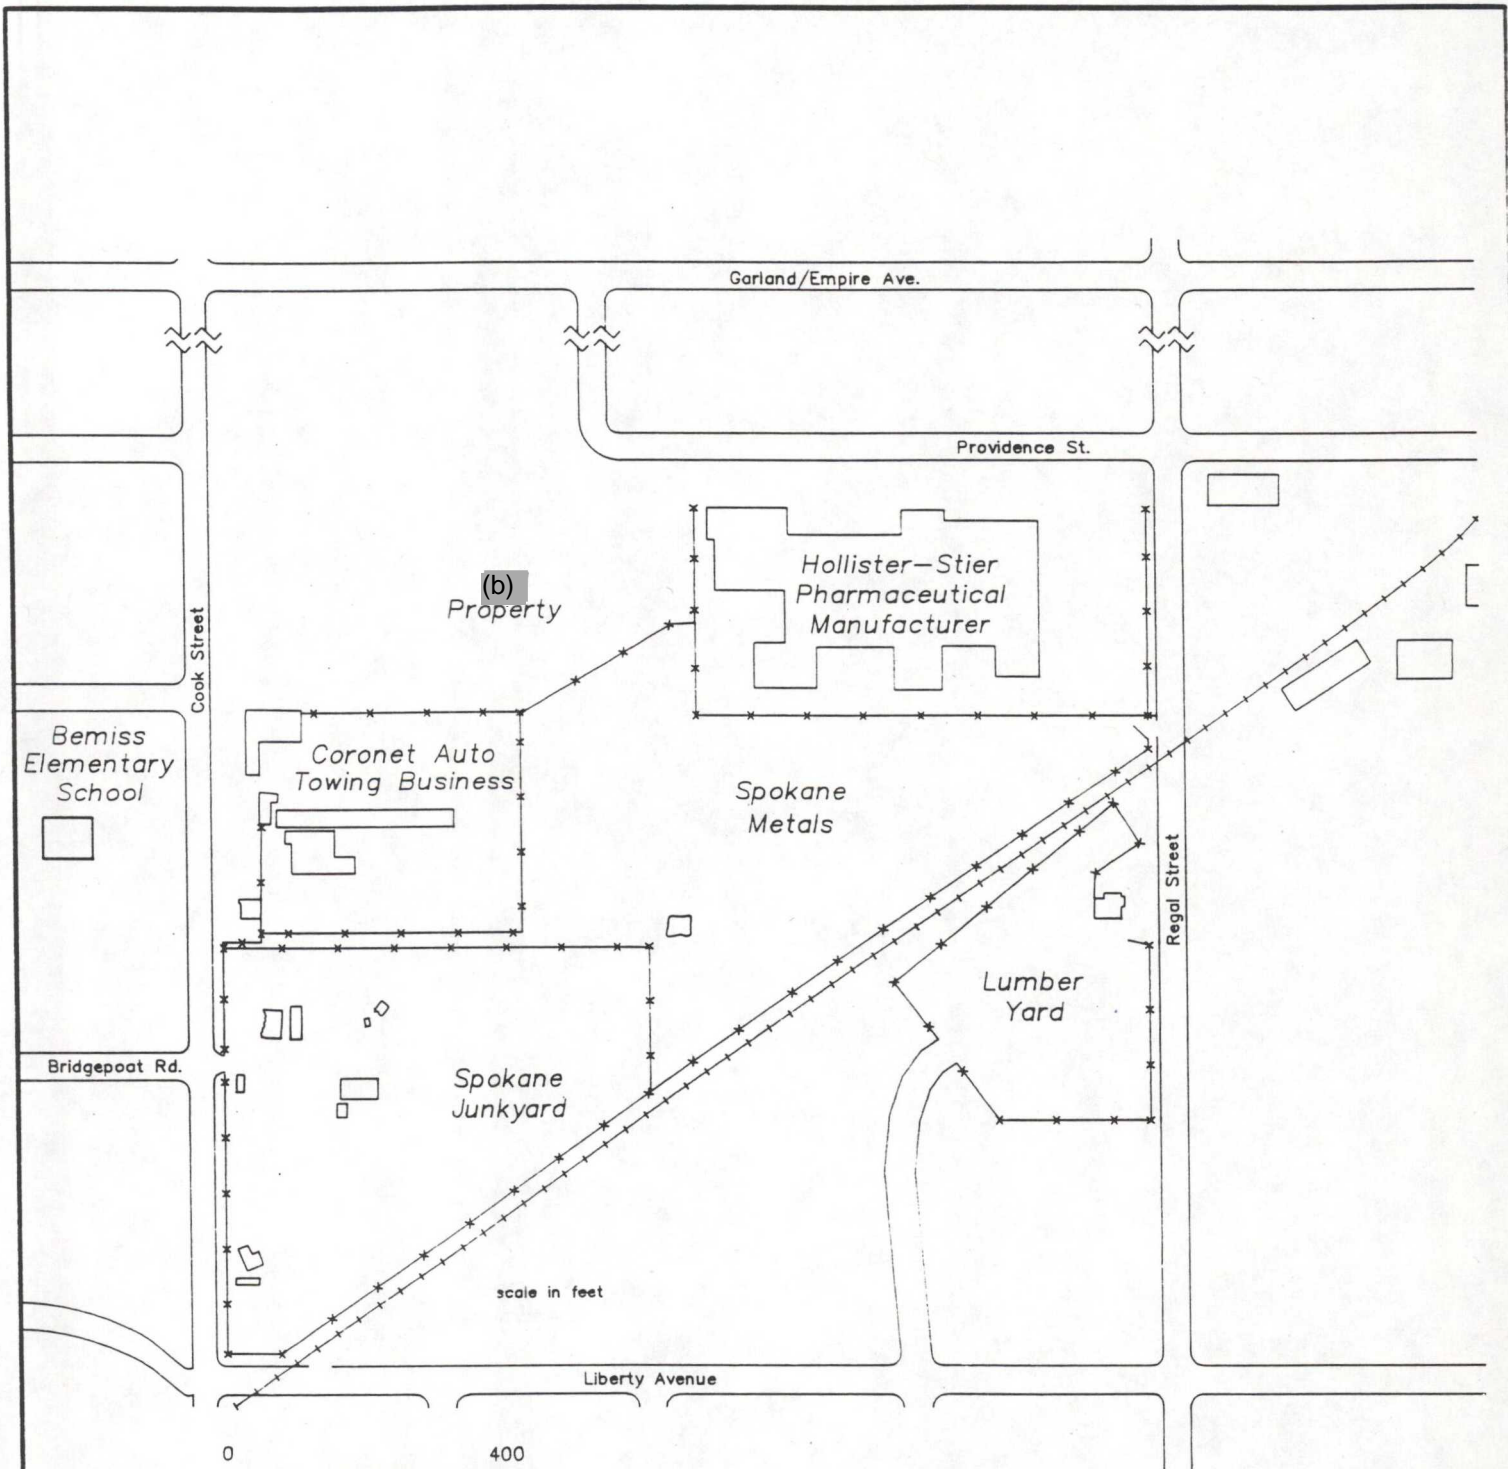
### FIGURE 1 SITE MAP

TAT suggests that once every 6 months there should be a site walk-around by a local resident, or possibly a police drive-by, to determine future fence damage. Signs could be posted every 150 feet on the fence along Cook Street to warn children from Bemiss Elementary School and local residents of the dangers, and every 300 feet along the rest of the fence to warn the general populous. The TAT suggests that the signs could be 2.5 feet by 2.5 feet, and made of steel with a diagonal steel bar to bolt on the back side of the fence. This would make it very difficult to remove the signs. The site maps depict the locations of each hole and subsequent repair (Appendix B).
